### **RU-C2 Remedial Action**

# RU-C2 Pre-Characterization PARCEL C

Hunters Point Shipyard March 2012

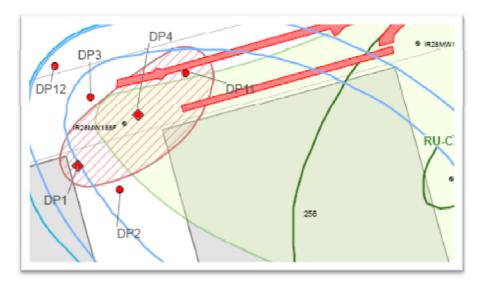
**Building 258 VOC Remediation Area**

DP1 through DP4 encountered competent bedrock (serpentine) at 3 feet bgs

- Air rotary rig required to penetrate bedrock
  - · Access limited by open trenches
- Soil vapor monitoring points

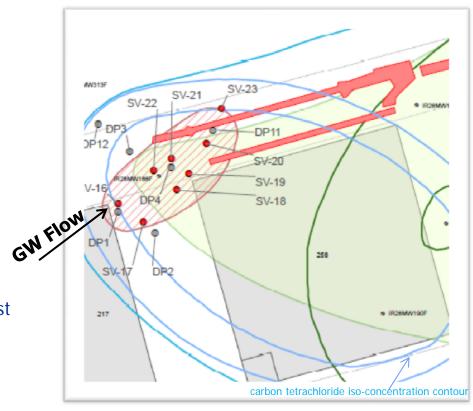
#### **Building 258 VOC Remediation Area**

- Proposed Soil Vapor Sampling
  - 8 Locations at 3 feet bgs
- SV-16 and SV-17: Target upgradient portion of remediation area.
- SV-18, SV-19: Target areas nearest to Building 258 and potential release areas.
- SV-21, SV-22: Target locations proposed nearest to existing monitoring well IR28MW188F.
- SV-20, SV-23: Target downgradient portions of the remediation area outlined in the ROD. Locations are nearest to open utility excavation pits.

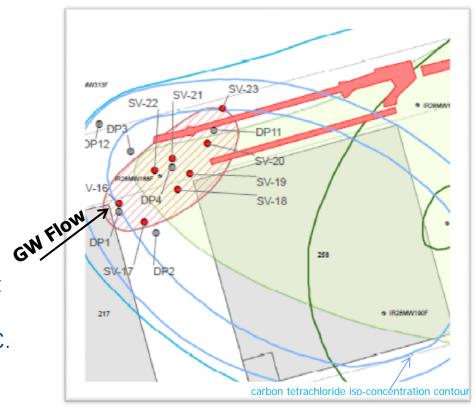
#### **Building 258 VOC Remediation Area**

- Scenario-1
  - Results: All detections below SGALs.
  - Data to RD contractor for no action, MNA, or ARIC.
- Scenario-2
  - Results: Select locations slightly above SGALs.
  - Data to RD contractor for possible localized hydropunch investigation with drill rig in areas with the highest detections in soil vapor.
  - MNA, localized bio injections, or ARIC.
